# Manhole Inspection Summary

Manhole # S05UU1024MH

**Location** Address: **3500 W NORTHERN PKWY**

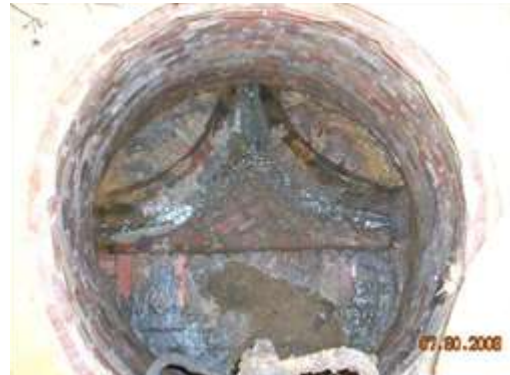
Top View

Corroded steps. Evidence of surcharge - Bench debris. Channel debris.

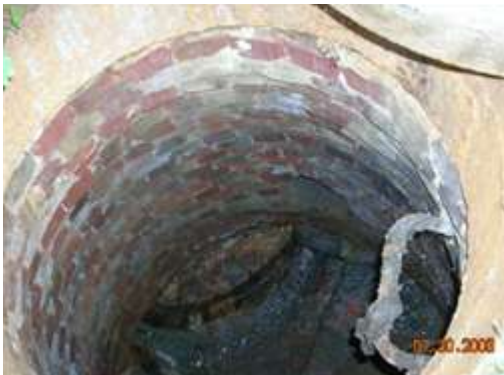
Defect

Frame leaks. Adjustment deterioration and infiltration. Corbel and Barrel infiltration - other side.

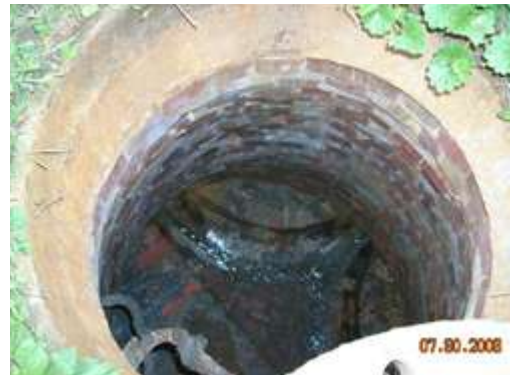
Defect

Frame leaks. Adjustment deterioration and infiltration. Corbel and Barrel infiltration.

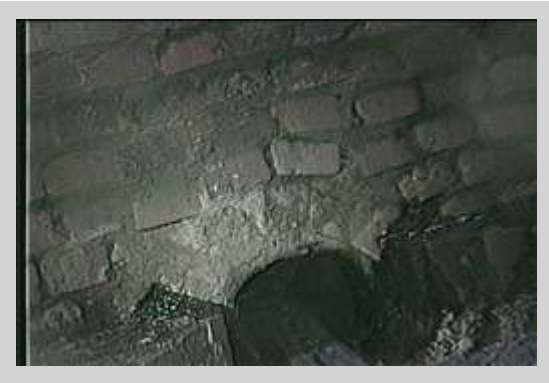
## 8 in. Circular Gravity Sewer Pipe Out @ 12 O'Clock

Barrel deterioration and infiltration.

Deposits: ☐ None ☐ Mud ☐ Sludge ☐ Debris ☒ Grease

Infiltration: **None** Pipe Seal Cond: **Cracked**

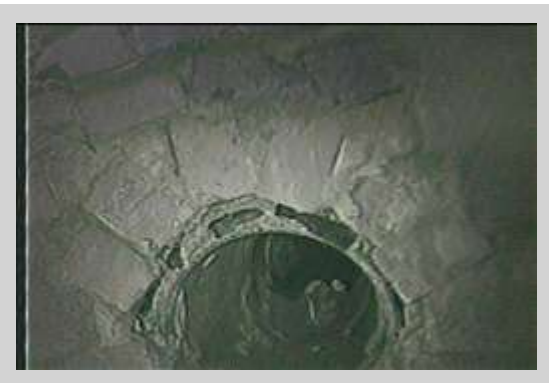
## 8 in. Circular Gravity Sewer Pipe In @ 3 O'Clock

Infiltration: **Evidence** Pipe Seal Cond: **Broken**

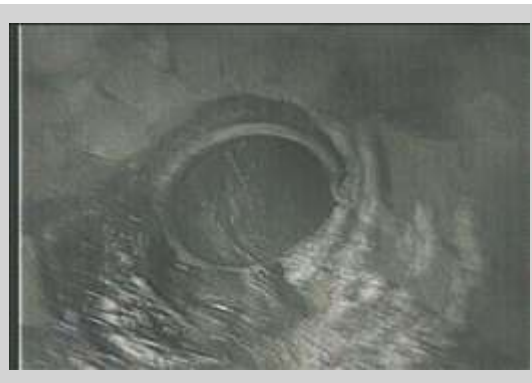
## Drop In @ 3 O'Clock

Drop Condition: **Partly Clogged**

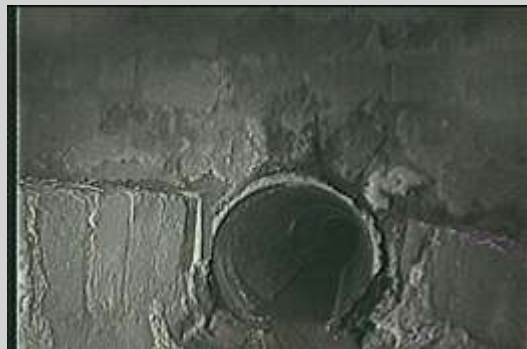
Pipe In @ 9 O'Clock

Comments **This MH is located in the school yard. The I9 pipe picture shows grease deposits in the Channel.**

Channel grease.

Infiltration: **Evidence**

Pipe Seal Cond: **Cracked**
